Percussion Tapping/Testing

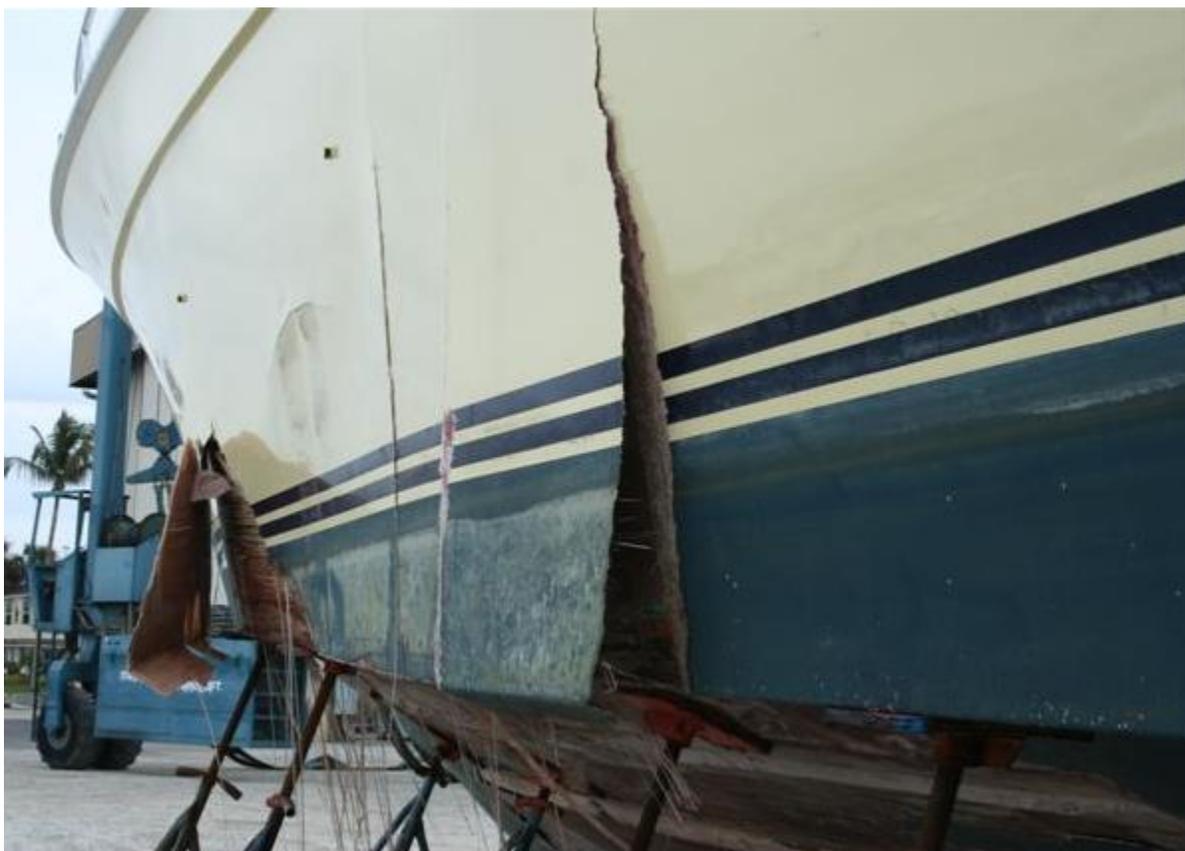
Photo of delamination between the outer skin and the core on a Bertram 63' Cruiser

Percussion tapping's primary use on a boat's is for determining the condition of fiberglass laminates. It is also useful when assessing the condition of wood and other construction materials. In fiberglass or composite boats, tapping allows detection of delamination. Fiberglass boats and their component parts are made of several layers of lamination. Gelcoat, coring and fiberglass material with resins are among the most common types of laminates. A separation or de-bond can occur at any level. Percussion testing allows detection of separation between the gelcoat and the first fiberglass laminate (skin coat). It can also detect delamination within any of the layers of the fiberglass, including delamination caused by osmosis (blisters) and debonding of layers adjacent to the core.

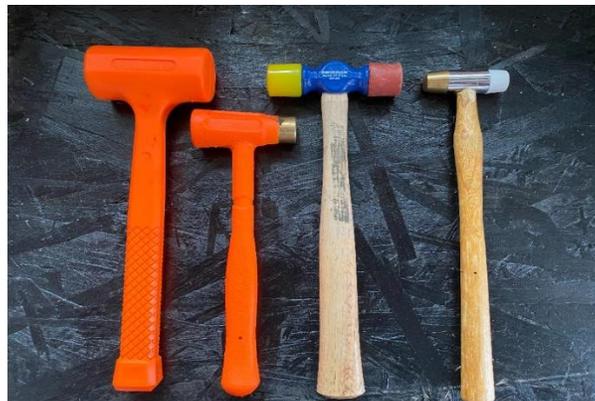
The tapping can be done with virtually anything. Depending on the material and thickness of the component which is being tapped variances can be found using the edge of a coin, the butt of a screwdriver or of course the preferred tool, a hammer. Some of the hammers I use to percussion tap are illustrated below.

Hammers can be made of bronze, steel, plastic or any hard material. As long as an audible report is made when the device taps the component being inspected. The difference in the sound made is what the surveyor is listening for. I have found metallic hammers give the most discernible reports, but I primarily use plastic hammers above the waterline.
